NORTH CAROLINA STATE HISTORIC PRESERVATION OFFICE

NATIONAL REGISTER OF HISTORIC PLACES

Marion House and Marion Brothers Store

Siloam, Surry County, SR0863, Listed 12/26/2012 Nomination by Laura A. W. Phillips Photographs by Laura A. W. Phillips, March 2012

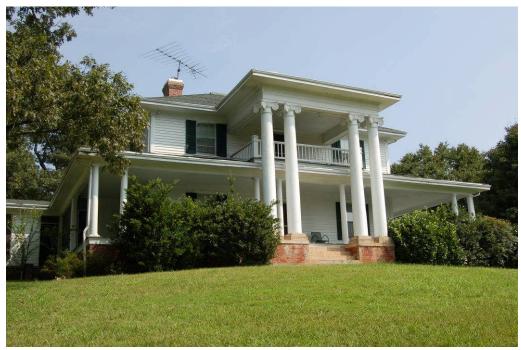
Façade view of house

The Marion House is a large, two-story, three-bay-wide, double-pile house with a brick foundation, weatherboard siding with plain cornerboards, an asphalt-sheathed, truncated hipped roof with overhanging boxed and molded eaves and a plain frieze, a front hipped dormer, and two interior brick chimneys. On the east and west sides of the main body of the house, the rear (north) rooms extend approximately five feet beyond the front (south) rooms. A one-story-with loft ell with a gable roof and cornice returns extends from the west side of the rear of the house. Its southeast corner is awkwardly angled inward to avoid hitting the west sidelights of the rear door of the house. The ell has a single, interior brick chimney at the north end. Straddling the roof ridge at the south end is a single room with a hipped roof that connects with the second story of the front part of the house. Extending from the west side of the main house is a narrow, one-story, hip-roofed wing that houses the well within a screened open passage. The well has a square brick base, a flat wood top with drilled holes for ventilation, and a wood frame that rises above the well on its south side to support the pulley system for the well bucket. At the west end of the passage, a narrow batten door leads to an enclosed cooling room, whose interior has exposed framing, wood shelving, and a deeply sunken concrete floor.

A two-story, Ionic central portico and a one-story porch with Tuscan columns that nearly encircles the house dominate its exterior appearance. Both the porch floor and ceiling are composed of tongue-and-groove sheathing. Concrete steps with brick cheek walls capped with concrete slabs rise to the porch on the front, on the east side, on west side of the ell, and on the south side of the open passage to the well and cooling room. The Tuscan columns of the one-story porch are arranged in groups of three at each corner, a pair behind each set of Ionic columns of the portico, a pair flanking the east-side steps, and single columns evenly space along the rest of the porch. The porch on the east side of the ell has been screened, as have the west-side porch from the south end of the southwest room to the kitchen and the open passage of the west wing with its well and cooling room. A small section on the south side of the west-wing porch was sheathed with German siding in the 1960s to create a protective wall against which a freezer was placed.

The two pairs of colossal Ionic columns on the portico of the south façade's center bay rise in front of the one-story porch to a classical entablature. The column bases rest on concrete slabs set on the brick cheek walls of the steps. Sheltered by the Ionic portico, a balustraded, second-floor, center-bay porch rests on the roof of the one-story porch. The balustrade is plain, but at the corners are classical posts that rise slightly above the handrail. A photograph of the house taken soon after its construction shows that there was a somewhat fancier balustraded deck atop the portico roof, but it does not survive (The date of its removal is not known.)

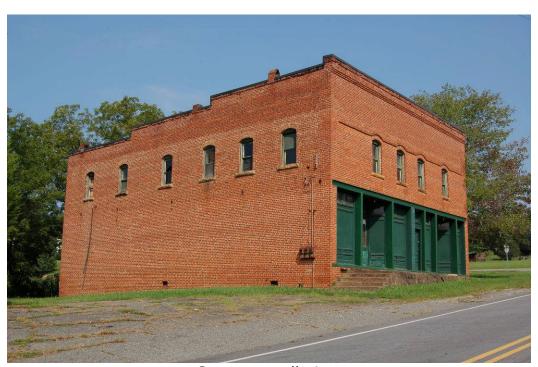
Store overall view

The Marion Brothers Store is a two-story brick commercial building that stands at the southwest corner of the Siloam and River Siloam roads and not far north of the railroad, just above the flood plain. It is the first building encountered upon entering Siloam from the south. The building has a brick foundation, five-to-one common bond brick walls, and a rubber-sheathed roof that slopes gently from east (front) to west. The roof is hidden on the front by a

The facade has two storefronts divided by a central door that opens to the front stair to the second floor. The façade is slightly asymmetrical. The south storefront is the larger of the two and takes up half the width of the building. The north storefront repeats the design of the south storefront, but is slightly compressed, because that half also includes the central door to the stair. A plain brick post, now painted, divides the two sides of the facade. Because the land slopes toward the river on the south, concrete steps at the south end of the façade rise to a concrete platform that runs along the building like a sidewalk. The storefronts have a metal base – except for the space in front of the north entrance, which is concrete – a metal lintel, and plain metal posts on either side of the north and south entrances and on the north side of the door to the stair. The remainder of the framework is wood. Each storefront has a central recessed entrance with a double-leaf door flanked by splayed sides and two shop windows. A multi-section transom carries across the whole. Each leaf of the entrance doors consists of four wood panels in the lower third and a glass panel above. The splayed sides flanking the doorway and the storefronts all have large glass panes set above a complex, paneled wood knee wall. Each of the windows is also headed by a molded band that matches the upper section of the knee wall. Some of the windows have been covered or replaced with plywood for protection. The ceilings above the recessed entrances are sheathed with beaded boarding. The door to the stair between the two storefronts has six wood panels and is headed by a transom. The second story of the façade has four one-over-one sash windows with rusticated granite sills and two-layer brick segmentalarched lintels. The four windows are not evenly spaced, although one is centered above each of the two recessed entrances. A raised brick stringcourse runs across the facade above the windows, curving upward to follow the lintel of each.
